**INDIAN RIVER COUNTY, FL
SECTOR 4 STORM DAMAGE REPORT:**

HURRICANES IAN & NICOLE

March 2023

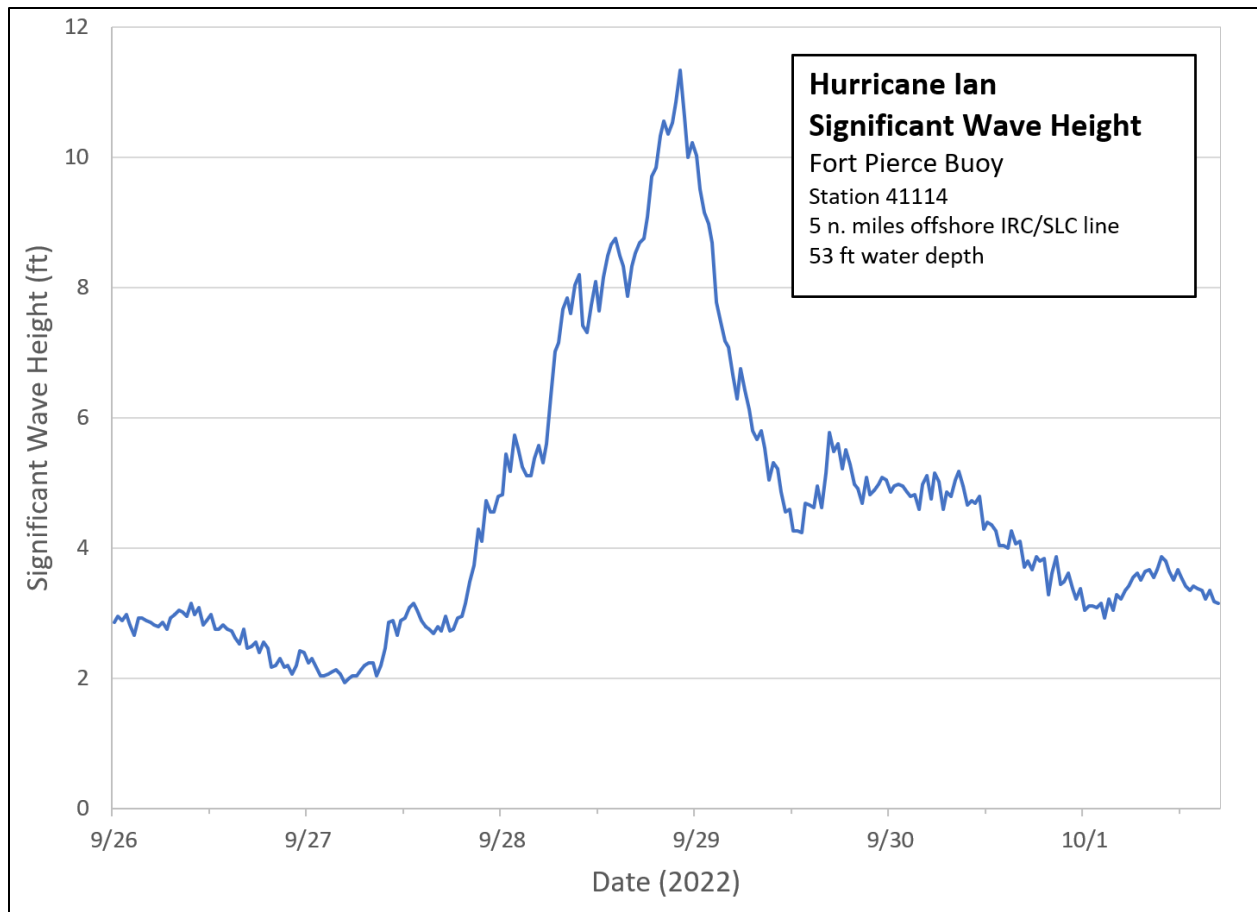
Figure 5. Significant Wave Heights Measured during Hurricane Ian.

Figure 5 displays the time series of significant wave height measured at the Fort Pierce Buoy as Hurricane Ian impacted the area. The significant wave heights reported at the buoy are an average of the largest 1/3rd of all wave heights during a 20-minute sampling period (thus, there were waves that passed the buoy during the 20-minute period that were larger than the reported height). Significant wave heights peaked at approximately 11 ft in the morning of September 29, as the storm passed offshore of the County.

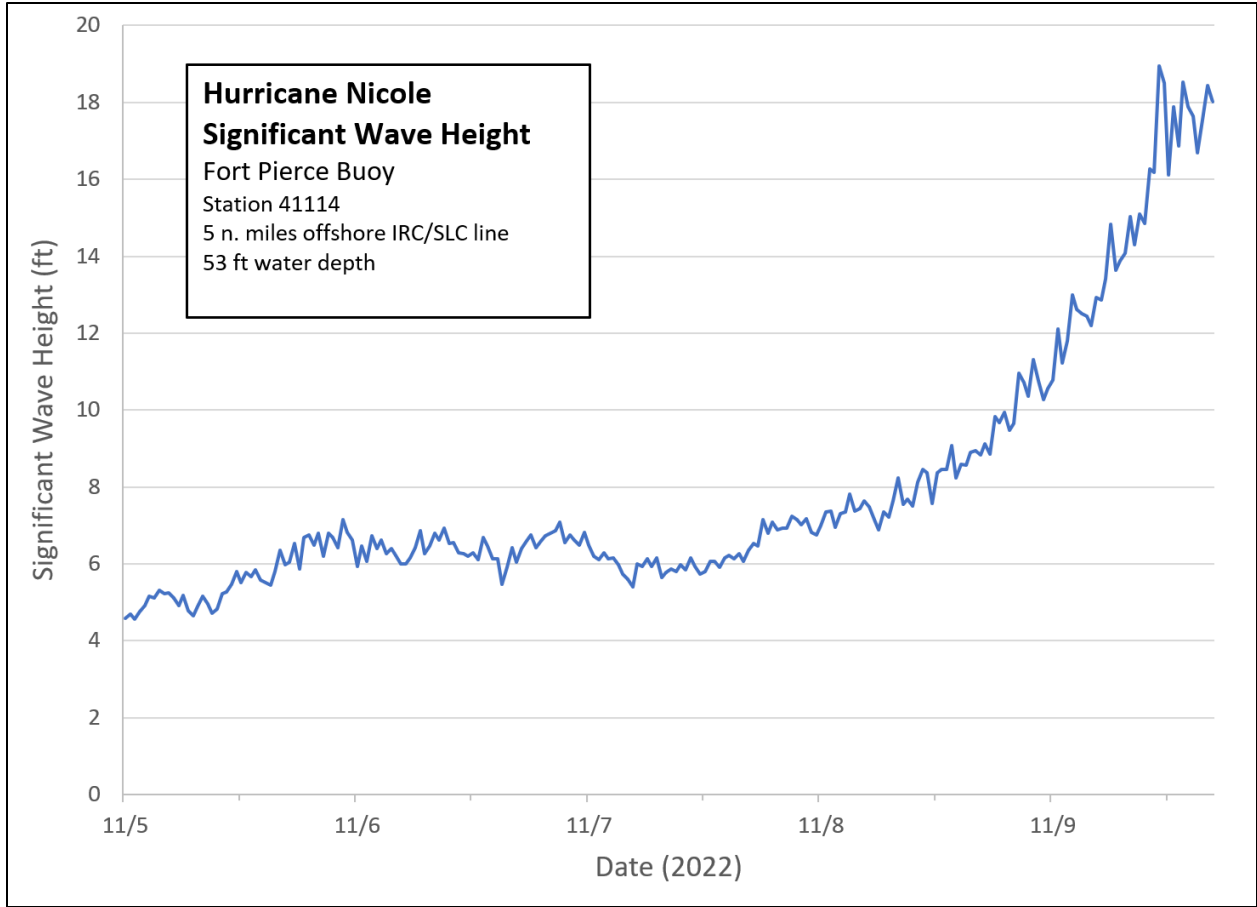
Figure 8. Significant Wave Heights Measured during Hurricane Nicole.

Figure 8 displays the time series of significant wave height measured at the Fort Pierce Buoy (NDBC #41114) as Hurricane Nicole impacted the area. Significant wave heights peaked at approximately 19 ft on November 9. The wave height readings went out shortly after the peak height was recorded. The storm's path relative to Indian River County resulted in elevated storm surge and large waves impacting the County's beaches for several days while the storm approached and impacted the County. The result was appreciable erosion to the beach berm and dunes of Sector 4. Post-storm photographs of the Sector 4 shoreline are found in **Appendix B**.

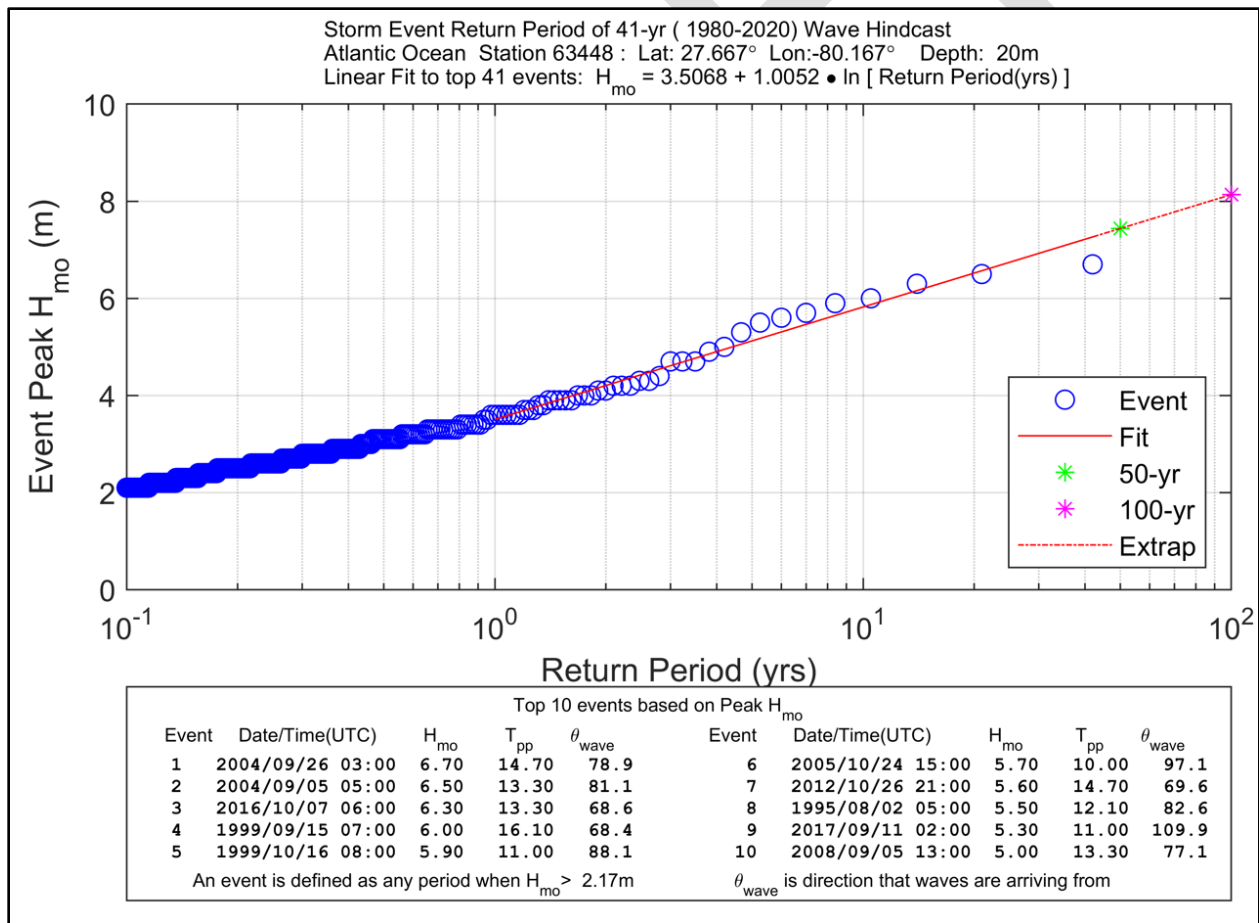
Figure 16. WIS Station 73300 Data.

Wave characteristics were taken from Wave Information Station (WIS) 63448 (**Figure 16**). This station is located offshore directly east of Sector 5 and is the best representative of deepwater conditions necessary for calculations. An equation was determined for the best linear fit to the top 41 events from 1981 to 2020. This equation was used to determine the H_{mo} for a 5-year return period. A T_p value was determined by averaging the 7th through the 10th largest storm events from the same data set.

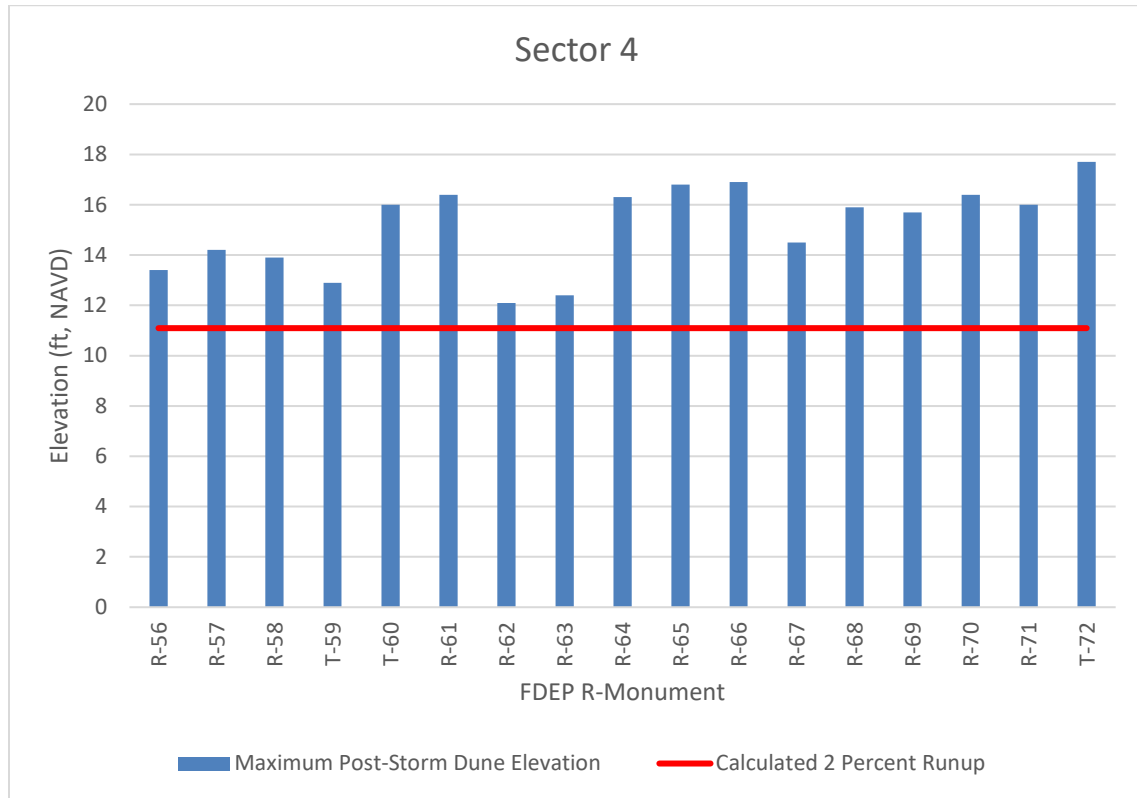
Figure 17. Sector 4 Max Dune Elevation and Total Runup Elevation.

The calculated runup value was then added to the 3.7-ft stillwater elevation to determine the total runup elevation for Sector 4 which is equal to 11.1 ft NAVD. The results of the calculations can be seen in **Figure 17**. The maximum dune elevation was determined for each profile from the Morgan & Eklund survey from January 2023. In Sector 4, the dune height at each R-monument is greater than the runup experienced with a 5-year storm. The Sector 4 profiles can be found in **Appendix A**. Although the maximum post-storm dune height minimally exceeds the total runup elevation, it is important to note the large loss of dune width within the project area and scarping of the dune due to wave action, which has already impacted an upland residence in the vicinity of

R-67. There is potential risk for damage to improved property if the total runup elevation is solely considered by FEMA for Category B funding within this area.
