# INDIAN RIVER SHORES **VULNERABILITY ASSESSMENT**

# Why do a Vulnerability Assessment?

Florida Statute 380.093

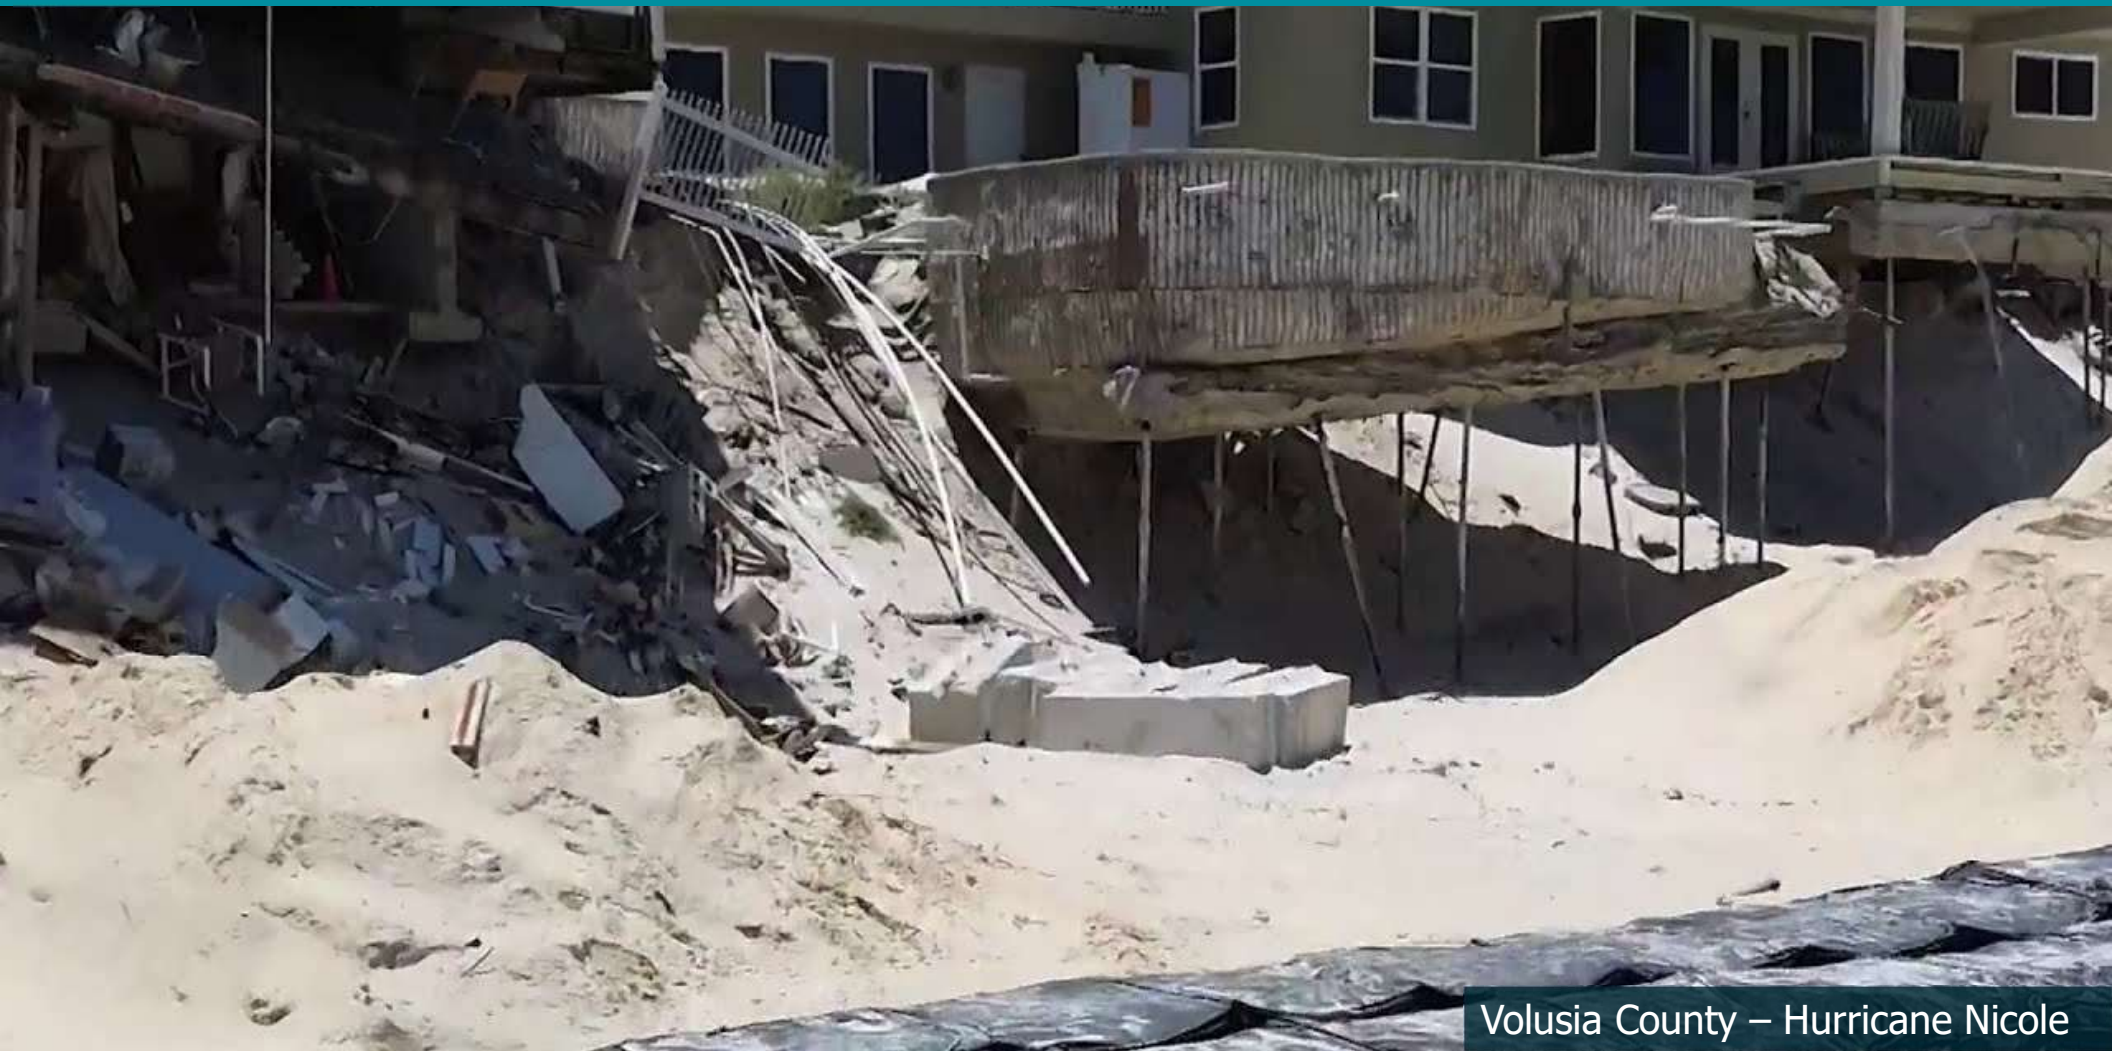
Volusia County – Hurricane Nicole
